TECH TALK 0082

ERP101 Electronic Remote Pulser Torque with New Seal

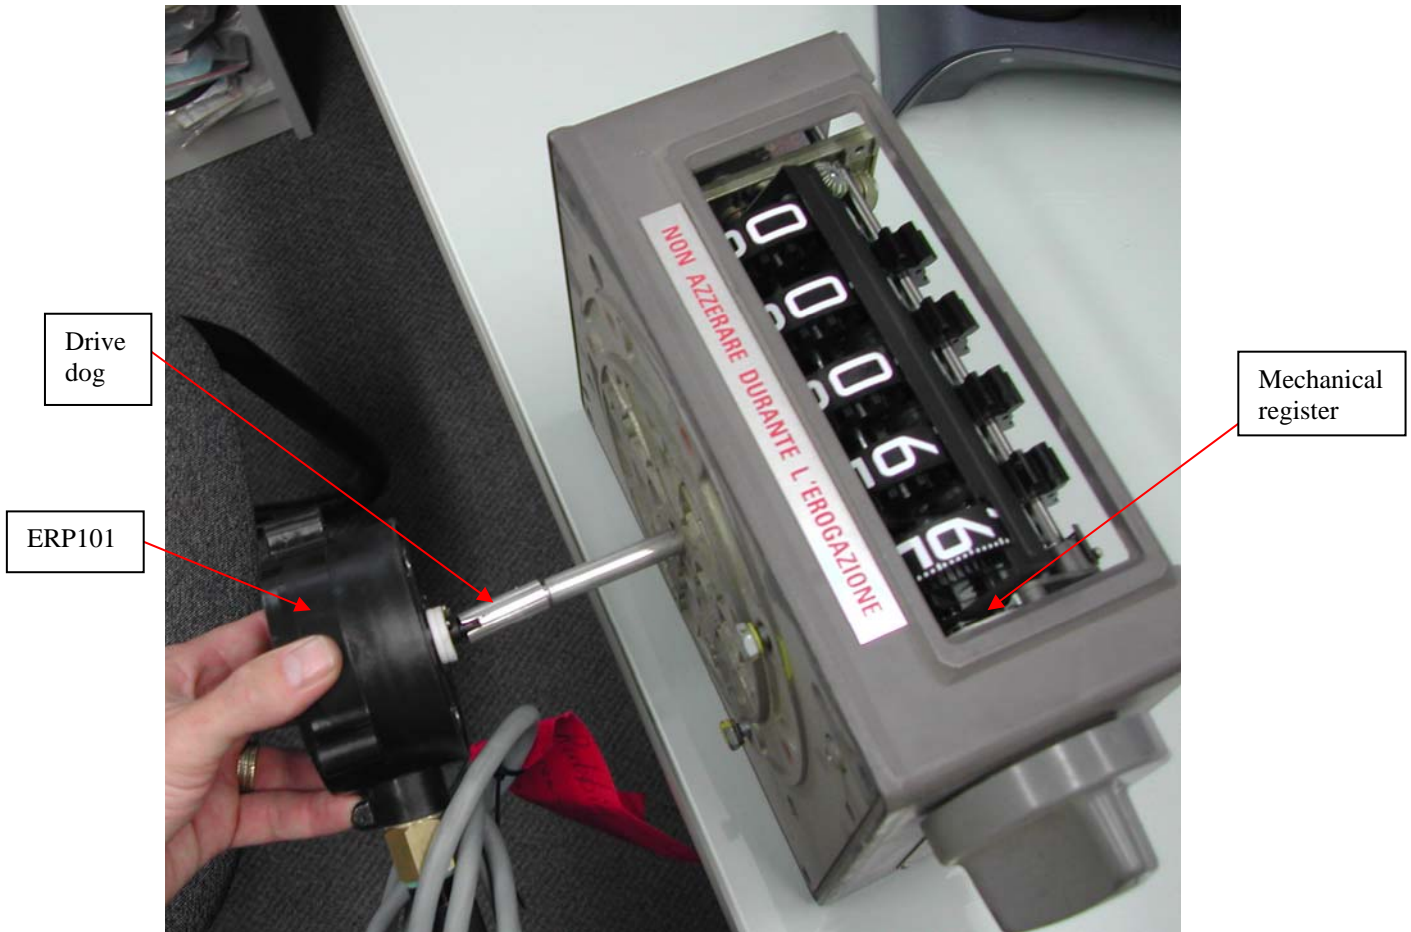
The ERP101 with new lip seal was connected via a drive dog to a mechanical register. The ERP101 was rotated. This was done to determine if the shaft of the ERP101 or the shaft of the mechanical register would move. The shaft with the greater torque will not move.

After several turns, the shaft of the ERP101 rotated 9 out of 10 times. This showed that the torques of the ERP101 & mechanical register are very close but the mechanical register greater.

As the torque of the ERP101 with lip seal is less than the mechanical register, the ERP101 will have no effect on the meters.
